MAHALLA 824 SEWER COLLAPSE PROJECT UNDER THE COMMANDER'S EMERGENCY RESPONSE PROGRAM BAGHDAD, IRAQ

SIGIR PA-07-112 JANUARY 16, 2008

SUBJECT: Report on the Rehabilitation of the Mahalla 824 Sewer Collapse Project in the Doura governorate of Baghdad, Iraq (Report Number SIGIR PA-07-112)

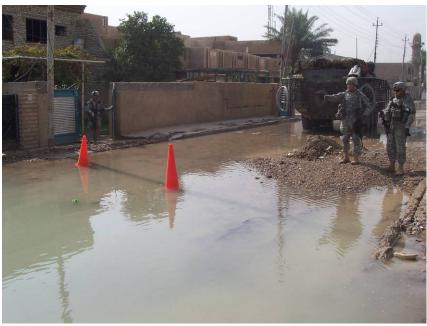
The description of the facility (pre-construction) was based on information obtained from the contract and the USACE project file. The Mahalla 824 Sewer Collapse Project is located in the Doura governorate of Baghdad, Iraq. The Doura area has been neglected for decades, and the collapsed sewer main created a huge pond of standing sewage. Figure 1 illustrates the Mahalla 824 Sewer project area, and Site Photos 1 and 2 show the pond of sewage.

Site Photo 1. Sewage pond (Photo courtesy of USACE)

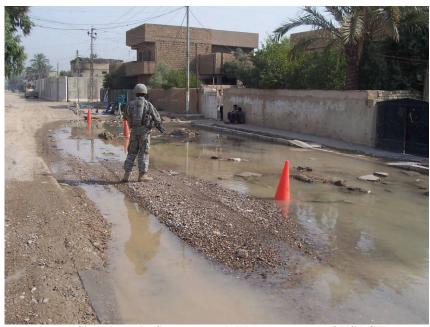
Site Photo 2. Sewage pond (Photo courtesy of USACE)

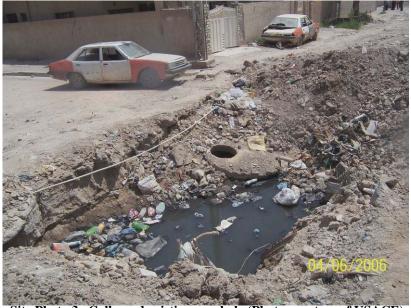
According to the USACE, the contractor had removed the existing pavement in the areas to be trenched and removed and replaced the contaminated soil from the sewage spill below the pipe grade. Then the contractor placed bedding material in the trench, installed the new sewer line, and backfilled the trench. In addition, the four existing manholes were removed (Site Photo 3), and four new manholes were constructed (Site Photo 4).

Site Photo 3. Collapsed existing manhole (Photo courtesy of USACE)

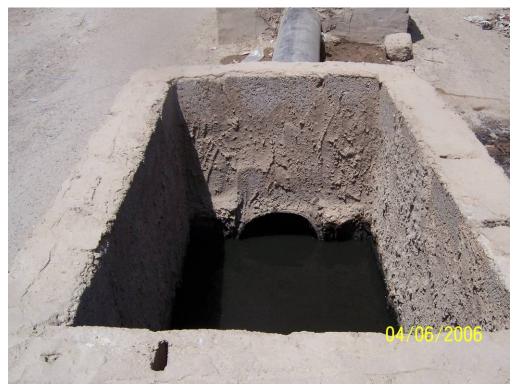
Site Photo 4. Constructed new manhole (Photo courtesy of USACE)

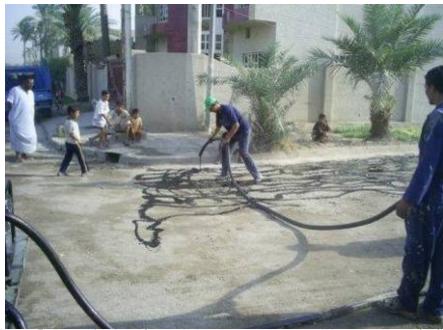
At the time of the assessment, the USACE stated that the contractor was completing the road. The contractor had filled in the trench, compacted the base material, and was in the pre-stages of paving the road (Site Photos 5 and 6).

Site Photo 5. Preparing base for asphalt concrete pavement (Photo courtesy of USACE)

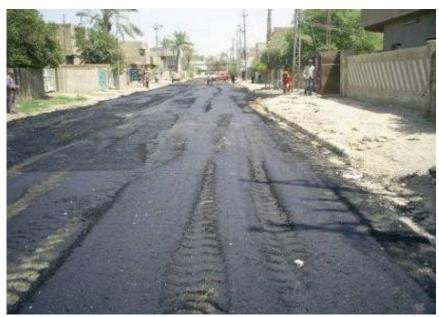
Site Photo 6. Preparing base for asphalt concrete pavement (Photo courtesy of USACE)
